After the aluminum shell was installed, I measured the home-made calibrator again, and measured the 1NF capacitance.

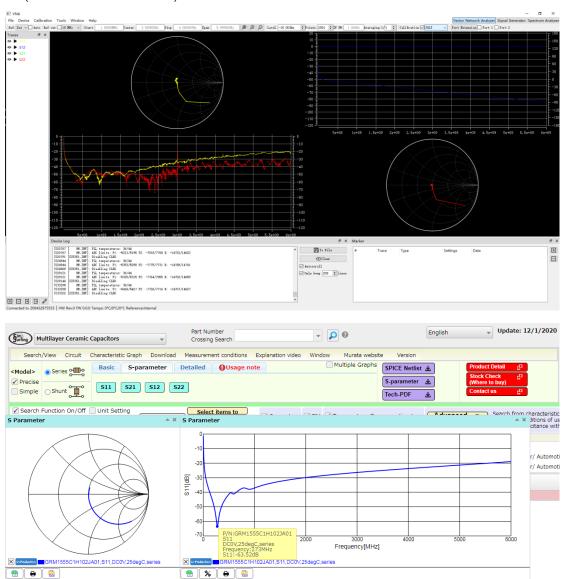
1nf(GRM1555C1H102JA01D)

The S21 at 273mhz is about 0.006db, and the normalized ESR is 0.069 Ω

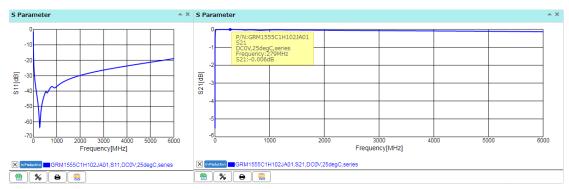
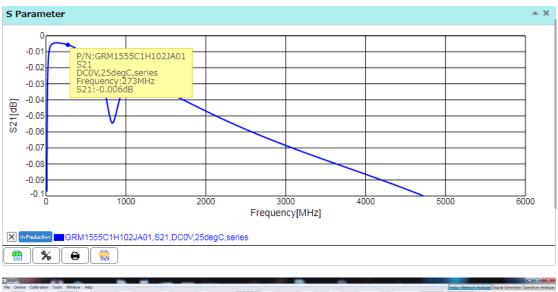
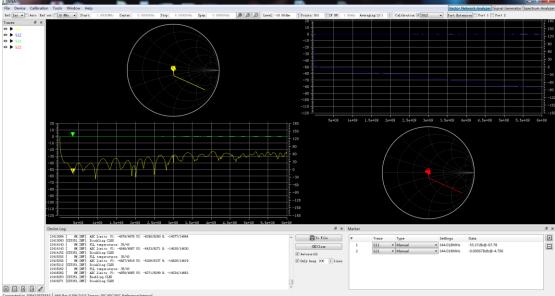
The values I tested is 0.00667db, and the normalized ESR is 0.0768 Ω , the error is 11.3%.

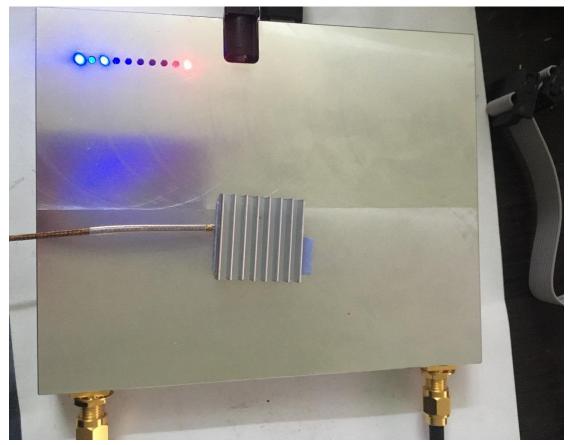
After the measurement, I used air thermocouple to make a rough temperature measurement on the metal surface.

The measured temperature was about 36 degrees, but it was still very high to feel the temperature by hand.
